**Flood Control Project Maintenance**  
**2019 Structure Summary Report**  
**Overall Unit and Item Ratings**

## DWR Sutter Maintenance Yard

### Butte Slough Drainage Structure

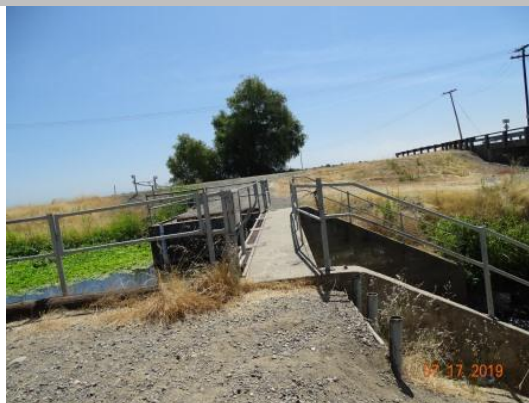
Photo 1 of 1 : ST\_2019\_NA0060\_11\_22\_20190718\_00008.jpg

LM Start	0.00	Rating **	A	Issue No.	22
LM End	0.00	Issue Type +	Ma	Location *	
Category	Structures & Concrete Lined Channels	GPS Latitude/Longitude			
		Start		End	
Item	Safety	39.153325 °		39.153325 °	
		-121.734122 °		-121.734122 °	
DWR ID	DWR_NA0060_11_t_2012_22				
Action/Comments					
Inspector Comments: There is a safety rail around the structure.

View of the safety railings around the structure.
